## Periodic Inspections of Concrete-Armored Coastal Structures

*by Robert R. Bottin, Jr.*

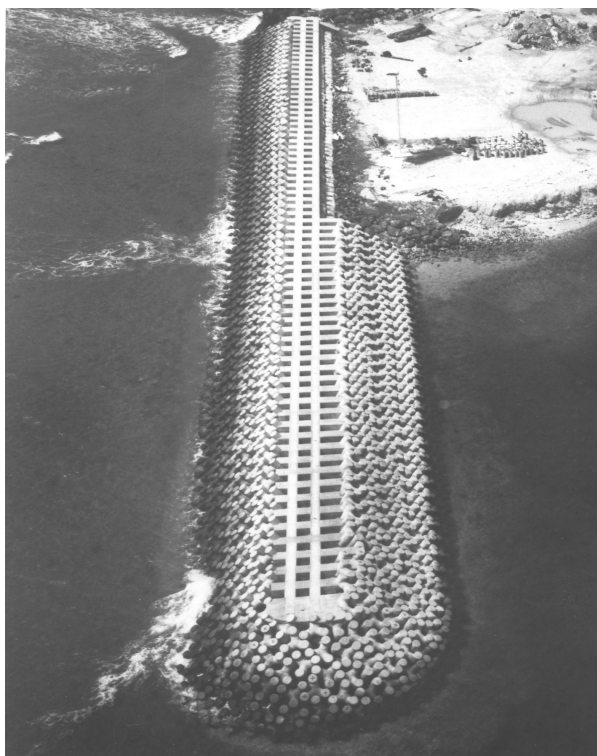
Figure 1. Ofu Harbor breakwater

The breakwater (Figure 1) is armored with a single layer of uniformly-placed 4,082.33-kg (4.5-ton) concrete tribar units. It has a concrete rib cap system on the crest to stabilize and buttress tribars at the upper sea- and harbor-side slopes. The structure has a crest elevation (el) of +4.57 m (+15 ft), and side slopes of 1V:1.5H. Due to the nonavailability of local stone, the structure was built utilizing a unique concrete design for the underlayer units. Basically the design entailed using various sized concrete units for breakwater construction as opposed to stone. Most of the underlayer consisted of 1,632.93-kg (1.8-ton) concrete units approximately  $1.22 \times 1.22 \times 0.61$ -m ( $4 \times 4 \times 2$  ft) with 5.08-cm (16-in.) holes in their centers and 22.86-cm (9-in.) semicircular holes on each side. When placed on the breakwater slope, the underlayer units, with the holes, resemble a slice of Swiss cheese and have been labeled Swiss cheese blocks. In addition, both 2,267.96-kg (2.5-ton) and 510.29-kg (1,125-lb) concrete units were formed by pumping high-strength, fine aggregate concrete into geotextile bags. The 2,267.96-kg (2.5-ton) units were used as a rib cap underlayer and placed along the harbor side of the structure near its origin. The 510.29-kg (1,125-lb) units were used as an underlayer for the tribars around the breakwater head since the Swiss cheese blocks could not be placed in this area due to the tight radius.

During the initial photogrammetric survey of October 1996, selected tribars were targeted (three targets each) and precise positions of these units were obtained as well as centroid data and orientations of the targeted armor units. A walking survey of the structure revealed no broken armor units, however, one sea-side tribar was slightly separated from the rib cap. In addition, it was noted that some of the Swiss cheese block underlayer units along the slope had slightly separated in a vertical direction. The maximum separation was about 20.32 cm (8 in.) The geotextile bags had deteriorated and some spalling along the edges of the 510.29-kg (1,125-lb) high-strength concrete underlayer units was also noted around the head of the structure. In general, the breakwater appeared to be in excellent condition.

The August 2002 photogrammetric survey of the breakwater revealed negligible movement of the concrete armor units relative to the 1996 survey. Maximum movement of the targets established on the tribar armor units in the horizontal and vertical directions, respectively, were 0.14 m (0.45 ft) and 0.106 m (0.35 ft); and the average movements of all horizontal and vertical targets were 0.012 m (0.04 ft) and 0.021 m (0.07 ft), respectively. Maximum movements of the target armor unit centroids were 0.088 m (0.29 ft) and 0.073 m (0.24 ft) in the horizontal and vertical directions, respectively, while average movements were 0.012 m (0.04 ft) and 0.024 m (0.08 ft) in the horizontal and vertical directions. Seventy-three percent of all vertical movements and 93 percent of horizontal movements were 0.03048 m (0.1 ft) or less. Changes in rotation angles of the armor units varied from 0.0 to 4.03 deg with an average of 0.64 deg. A walking inspection of the structure in 2002 revealed no broken tribars. Fifteen sea-side tribars were slightly separated from the rib cap as opposed to one in 1996. On the entire sea side of the structure, it was noted that the Swiss cheese block underlayer units had separated along the slope between the third and fourth rows (down from the crest). Typical separations ranged from 2.54 to 10.16 cm (1 to 4 in.), and the maximum was 20.32 cm (8 in.). Some underlayer separations 2.54 to 10.16 cm (1 to 4 in.) were also noted on the harbor side of the structure. Separations between the cheese block underlayer units were more widespread as opposed to the 1996 inspection. The 510.29-kg (1,125-lb) high-strength concrete underlayer units around the head of the structure looked the same as the previous inspection. Even though slight movement in the breakwater's underlayer armor units had occurred, the breakwater appeared to be in excellent condition. It has not been subjected, however, to a major tropical storm, typhoon, or hurricane since its construction.

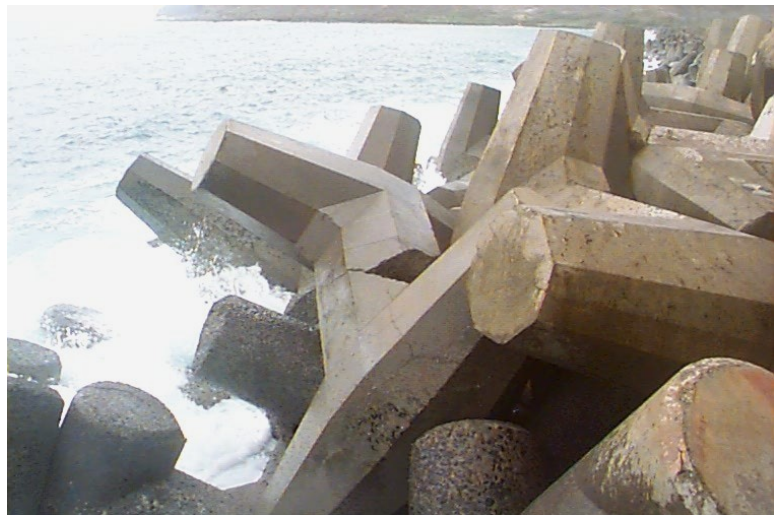
Figure 2. Trunk of Nawiliwili breakwater

Originally constructed with stone armor, the outer portion of the breakwater was later armored with several sizes of dolos and tribar concrete armor units 9,979.03- and 20,865.25-kg- (11- and 23-ton) dolos, and 5,896.70- and 16,147.89-kg (6.5- and 17.8-ton) tribars). It includes a concrete rib cap that provides buttressing for the armor and access along its alignment. The structure has a crest el of +4.88 m (+16 ft). Side slopes along the sea-side slope and the trunk (Figure 2) are 1V:2H, and slopes on the harbor side of the breakwater are 1V:1.5H. In general, the sea-side

slope and head were armored with 16,147.89-kg (17.8-ton) tribars. Subsequent repairs involved 9,979.03-kg (11-ton) dolos along the sea-side trunk and 20,865.25-kg (23-ton) dolos around the head of the structure. The 5,896.70-kg (6.5-ton) tribars were used to repair a portion of the harbor-side slope.

During the initial photogrammetric survey of September 1995, selected armor units 16,147.89-kg (17.8-ton) tribars and 9,979.03- and 20,865.25-kg (11- and 23-ton) dolosse) were targeted (three targets each) and precise positions of these units were obtained as well as centroid data and orientations of the targeted armor units. The initial broken armor unit survey of the Nawiliwili Harbor breakwater revealed a total of 70 broken or cracked armor units above the waterline. Of the 70 broken or cracked armor units, 39 were 9,979.03-kg (11-ton) dolos, 19 were 16,147.89-kg (17.8-ton) tribars, 8 were 20,865.25-kg (23-ton) dolosse, and 4 were 16,147.89-kg (6.5-ton) tribars. Considering the types of breaks, 54 percent of the 9,979.03-kg (11-ton) dolosse and 63 percent of the 20,865.25-kg (23-ton) dolosse were determined to be mid-shank breaks. Of all the dolos breaks recorded, 77 percent were straight and 23 percent were angled. Of the 19 broken 16,147.89-kg (17.8-ton) tribars, 74 percent consisted of one leg broken off through the center of the unit. The four broken 6.5-ton tribars on the harbor-side of the breakwater appeared to have been placed in that condition. They seemed to have been fitted on the crest adjacent to the rib cap. It was noted during the inspection, that due to excessive wave action, broken/cracked armor units along the sea-side water's edge may have been missed in the previous inspection, since that portion of the structure was inaccessible by foot.

The September 2001 photogrammetric survey indicated negligible movement of the concrete armor units on the breakwater relative to the 1995 survey. Maximum movement of the targets established on the concrete armor units in the horizontal and vertical directions, respectively, was 0.1280 m (0.42 ft) and 0.1381 m (0.45 ft); and the average movement of all horizontal and vertical targets was 0.0304 m (0.1 ft) and 0.0457 m (0.15 ft). Maximum movements of the targeted armor unit centroids were 0.1036 m (0.34 ft) and 0.1127 m (0.37 ft) in the horizontal and vertical directions, respectively, while average movements were 0.0274 m (0.09 ft) and 0.0426 m (0.14 ft) in the horizontal and vertical directions. Changes in the rotation angles of the armor units varied from 0.0 to 10.2 deg with an average of 0.8 deg. A broken armor unit survey conducted during August 2001 revealed 77 broken or cracked armor units above the waterline (versus 70 in 1995). Additional broken units identified since the last survey included five 9,979.03-kg (11-ton) dolosse and two 16,147.89-kg (17.8-ton) tribars. However, as stated previously, high wave action during the 1995 walking inspection prevented a close examination of armor units on the sea-side water's edge. Of the seven additional broken units identified in 2001, six were located along the water's edge and may have been overlooked in 1995 due to the excessive wave action. Therefore, it appears that minimal armor unit breakage occurred between 1995 and 2001. Overall, the structure appeared to be in good condition.

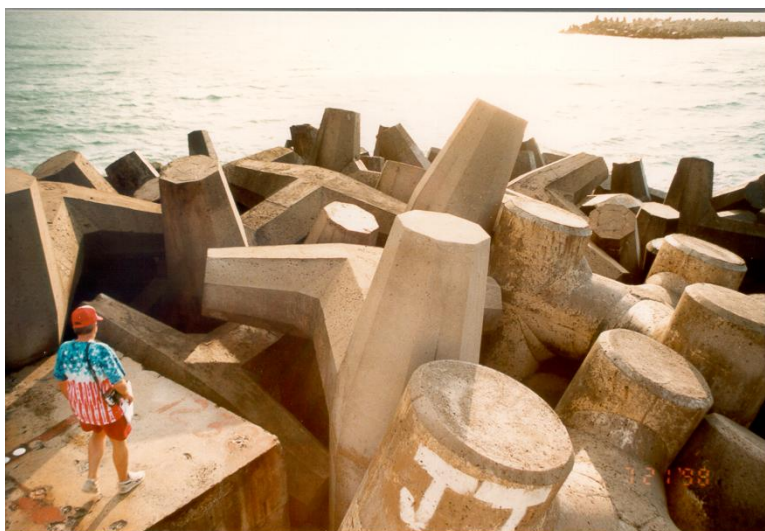
Figure 3. Head of Kahului west breakwater

During the initial photogrammetric survey of August 1993, selected armor units (5,443.10- and 27,215.54-kg (6- and 30-ton) dolos and 5,896.70-, 8,164.66-, 9,979.03-, and 31,751.47-kg (6.5-, 9-, 11-, and 35-ton) tribars) were targeted (three targets each) and precise positions of these units were obtained. Centroid data positions and orientations of the targeted armor units relative to the x, y, and z axes were obtained as well. Documentation of broken/cracked armor units by foot was not conducted as part of the periodic inspection in 1993.

The August 2001 photogrammetric survey indicated close agreement between positions of the concrete armor units relative to the 1993 survey for most of the targets. For the east breakwater, maximum movements of the targets established on the concrete armor units in the horizontal and vertical directions, respectively, were 0.94 m (3.1 ft) and 1.52 m (5.0 ft); however this level of difference occurred for only one target for the horizontal and one target in the vertical position. Both these targets were on units situated around the seaward head of the structure. The average movements of all horizontal and vertical targets on the east breakwater were 0.15 and 0.16 m (0.51 and 0.54 ft), respectively. Maximum movements of the targeted armor unit centroids on the east breakwater were 0.54 and 0.67 m (1.8 and 2.2 ft) in the horizontal and vertical directions, respectively, while average movements were 0.12 and 0.17 m (0.39 ft and 0.57 ft) in the horizontal and vertical directions. For the east breakwater, changes in the rotation angle of the armor units varied from 0.03 to 24.57 deg with an average of 3.09 deg. For the west breakwater, maximum movements of the targets in the horizontal and vertical directions were 0.13 and 0.11 m (3.8 and 1.9 ft), respectively; however, this level of difference occurred on only one armor unit. The average movements of all horizontal and vertical targets, respectively, were 0.11 and 0.06 m (0.42 and

0.36 ft). Maximum horizontal and vertical centroid movements, respectively, for the west breakwater were 0.64 and 0.18 m (2.1 and 0.6 ft), while average movements were 0.11 and 0.06 m (0.37 and 0.21 ft) in the horizontal and vertical directions. Changes in rotation angles varied from 0.0 to 17.32 deg for the west breakwater with an average of 2.02 deg. Even though some units had moved 0.91 to 1.5 m (3 to 5 ft) on the breakwaters, visual observations indicated they had not broken and continued to be functional. A broken armor unit survey conducted during August 2001 revealed 29 broken or cracked armor units above the waterline on the east breakwater and 58 on the west structure. Of the 29 broken units on the east breakwater, 19 were 5,443.10-kg (6-ton) dolosse, two were 8,164.66-kg (9-ton) tribars, four were 27,215.54-kg (30-ton) dolos, and four were 31,751.47-kg (35-ton) tribars. Of the 58 broken units on the west breakwater, four were 5,896.70-kg (6.5-ton) tribars, one was a 9,979.03-kg (11-ton) tribar, 16 were 17,236.51-kg (19-ton) tribars, 18 were 18,143.64-kg (20-ton) dolos, 11 were 27,215.54-kg (30-ton) dolos, five were 29,937.1-kg (33-ton) tetrapods, and three were 31,751.47-kg (35-ton) tribars. Concentrations of broken armor units were identified on various areas of the breakwaters. Considering the types of breaks for the 52 broken dolosse on both structures, 75 percent had shank-fluke breaks, 16 percent had fluke-shank breaks, 9 percent had mid-shank breaks. Of the dolos breaks recorded, 78 percent were straight and 22 percent were angled. Considering the types of breaks for the 35 tribars and tetrapods on the breakwaters, 89 percent included units with breaks through the center sections where one or more legs had separated, and 11 percent had just portions of a leg broken off the unit. These data establish a base from which to evaluate future breakage in subsequent surveys. Even though some breakage has occurred, the structures appeared to be in good condition overall.

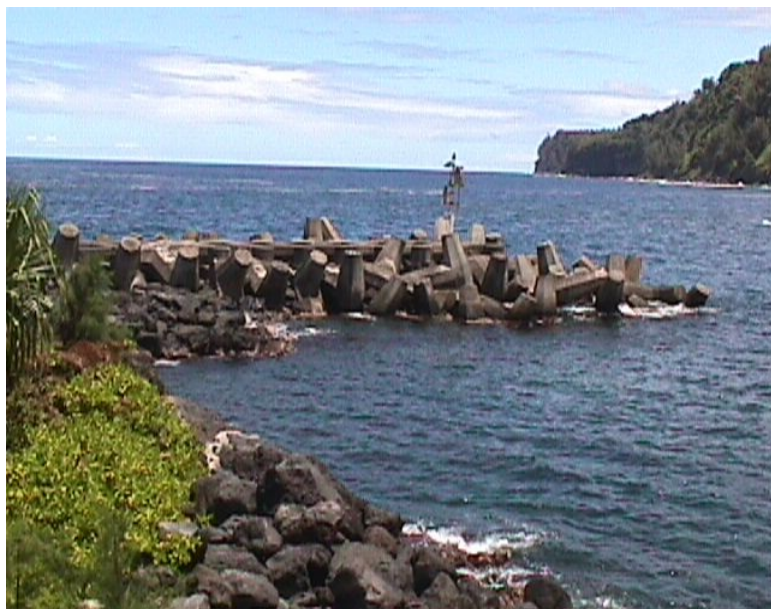
Figure 4. Laupahoehoe breakwater

The breakwater (Figure 4) is armored with 30-ton dolosse and the crest is stabilized with a concrete rib cap. The crest elevation of the structure is +3.66 m (+12 ft). Side slopes along the sea side and the breakwater head vary from 1V:2H to 1V:2.5H and slopes on the harbor side of the structure vary from 1V:1.5H to 1V:2H.

relative to the x, y, and z axes were obtained as well. No broken/cracked armor units were documented during the walking inspection.

The September 2001 photogrammetric survey indicated minimal horizontal and vertical movement of the targeted units relative to the previous survey. Maximum movements of the targets in the horizontal and vertical directions, respectively, were 0.10 m and 0.13 m (0.34 ft and 0.43 ft). The average movements of all horizontal and vertical targets, respectively were 0.03 and 0.05 m (0.1 and 0.16 ft). Maximum movements of the targeted armor unit centroids were 0.0914 and 0.085 m (0.3 and 0.28 ft) in the horizontal and vertical directions, respectively, while average movements were 0.0304 and 0.0335 m (0.1 ft and 0.11 ft) in the horizontal and vertical directions. Changes in the rotation angle of the armor units varied from 0.01 to 0.36 deg with an average of 0.1 deg. No broken or cracked armor units were observed during the walking inspection. The structure is considered to be in excellent condition.

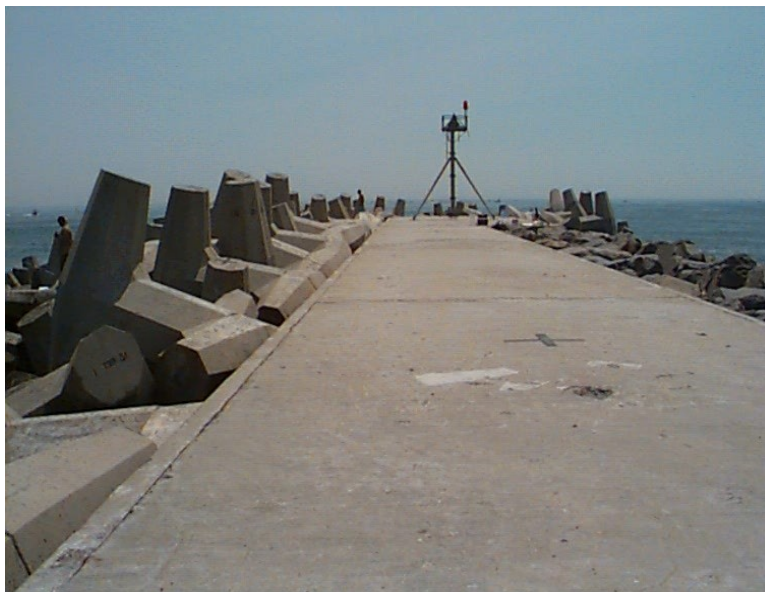
Figure 5. Manasquan north jetty

During the major rehabilitation of 1982, the outer 121.92 m (400 ft) of the north jetty (Figure 5) and 76.2 m (250 ft) of the south jetty were armored with 14,514.96-kg (16-ton) dolosse. The jetty crests were concrete caps with elevations of +4.26 m (+14 ft). Side slopes for the dolosse were 1V:2H. Additional repairs were conducted in 1997 that included the placement of 29 CORE-LOCs™ on the north jetty and 16 CORE-LOCs on the south structure. Also, some of the dolosse were repositioned to improve interlocking and allow space for the new CORE-LOCs. Several broken dolosse were removed. The CORE-LOCs used for the repairs were 17,236.51-kg (19-ton) units.

The May 1994 photogrammetric survey indicated that the targeted dolosse on the north and south jetties had been dynamic since the initial monitoring ended in 1984. Horizontal movement had ranged up to 2.01 m (6.6 ft) and vertical displacement (subsidence) as much as 1.62 m (5.3 ft). Dolos movement on the north jetty was slightly greater than those on the south. From 1984 to 1994 about 73 percent of the targeted units on the north jetty and 86 percent of the units on the south jetty had moved less than 0.3048 m (1 ft). Conversely, about 13 and 4 percent of the north and south jetty units, respectively, had moved distances greater than 0.91 m (3 ft). With regard to el changes between 1984 and 1994, 93 percent of the dolosse on the north jetty and 95 percent of those on the south structure had subsided. Between 1984 and 1994, the average movements of horizontal and vertical targets on the north jetty were 0.2743 m and 0.2438 m (0.9 ft and 0.8 ft), respectively; and on the south jetty the average movement was 0.1828 m (0.6 ft) both horizontally and vertically. The 1994 broken armor unit survey revealed 17 broken/cracked dolosse as opposed to five in 1984. Of the broken/cracked units, nine were located on the north jetty and eight were situated on the south structure. Pieces of the armor units were separated on 10 dolosse. Four dolosse were broken and being held together by rebar, and four had only hairline cracks. Considering the types of breaks, the majority (10 units) had shank-fluke breaks. There were five mid-shank breaks and two fluke-shank breaks. There were nine angled breaks and eight straight ones. Fifteen of the 17 units were

concentrated around the jetties' seaward heads. An area of concern was noted during the walking inspection at the tip of the south jetty where a broken unit had resulted in exposure of the core stone under the jetty cap. During the period October 1991 through March 1994, three major storm events (northeasters) occurred in the vicinity of Manasquan Inlet. These events probably significantly contributed to the armor unit movement and breakage at the heads of the jetties.

The August 1998 photogrammetric survey revealed significantly less dolos movement between 1994 and 1998 as detected during previous survey periods. Movement of dolos targets in the horizontal direction ranged from 0 to 0.55 m (0 to 1.8 ft), and vertical displacement ranged from 0 to 0.07 m (0 to 0.22 ft). Only three target positions on the north jetty moved over 0.15 m (0.5 ft) in the horizontal direction, and all other targets on the north structure moved 0.08 m (0.25 ft) or less. On the south jetty, all targets moved 0.06 m (0.21 ft), or less, horizontally. In the vertical direction, target movement did not exceed 0.07 m (0.22 ft) on the north jetty and 0.06 m (0.21 ft) on the south structure. Between 1994 and 1998, the average movements of the targets on the north jetty were 0.05 and 0.03 m (0.15 and 0.09 ft) in the horizontal and vertical directions, respectively. On the south jetty, the average movements of the targets in the horizontal and vertical directions, were 0.02 and 0.03 m (0.07 and 0.09 ft), respectively. During the previous surveys, the more significant movement occurred around the heads of the jetties. During this period (1997), however, the jetty heads were rehabilitated with CORE-LOCs. Some dolosse were covered and/or repositioned during this process. Therefore, no correlation in movement could be made for armor units in areas where the more significant movement had occurred previously. During the November 1998 broken armor unit survey, eight broken/cracked dolos armor units were observed. Four broken units were observed on each structure. Of the eight broken armor units observed, six were identified in the previous 1994 survey, and two were new breaks. As stated earlier, 17 broken units were observed in 1994. During the 1997 CORE-LOC rehabilitation, however, several broken dolosse were removed from the heads of the structures. Records indicate that several northeasters occurred between 1994 and 1998. During the 1998 periodic inspection, initial base data were obtained for the CORE-LOC armor units installed on the heads of the jetties. These data will establish a base from which to evaluate the effectiveness and analyze the performance of the CORE-LOCs in subsequent inspections.
